UNITED STATES ENVIRONMENTAL PROTECTION AGENCY REGION 4

MEMORANDUM

SUBJECT: 2009 GW Monitoring Report for the Grenada Manufacturing Site
FROM: David N. Jenkins, Environmental Scientist
Technical Support Section, Superfund Support Branch
THROUGH: Glenn Adams, Section Chief, Technical Support Section, Superfund Support Branch
TO: Meredith Anderson, RCRA Project Manager
Meredith,

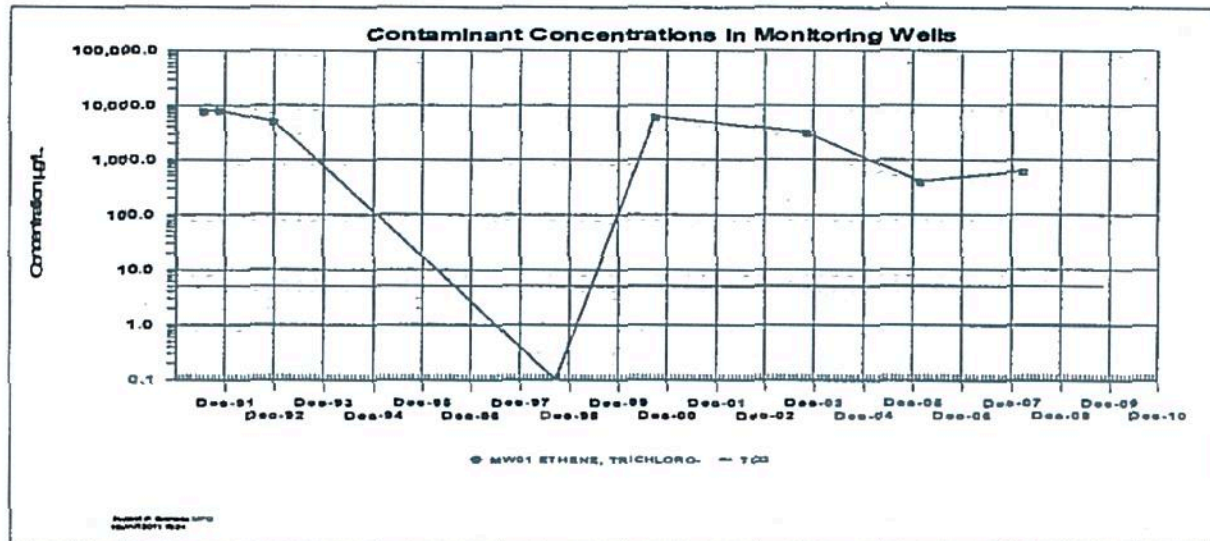
page 1/9). The data from MW-1 plotted on the graph below suggests that the TCE concentration in October 1998 probably was much greater than the target cleanup level (TCL) of 5µg/L, but Table 5 show this result for this sample simply with a "U" qualifier. The TCE concentration in the October 1998 sample from well MW-1 is unknown. A very low TCE concentration (0.1µg/L) was used to represent the October 1998 sample event in the graph below.

This graph shows why none of the laboratory results in Tables 5, 6 or 7 which are marked only with a "U" qualifier can be assumed to be non-detect at concentrations below a target cleanup goal. Please note that a TCG in the graph like the one above may be an MCL, a State ARAR or a site-specific Remedial Action Objective from a ROD concentration depending on the contaminant.

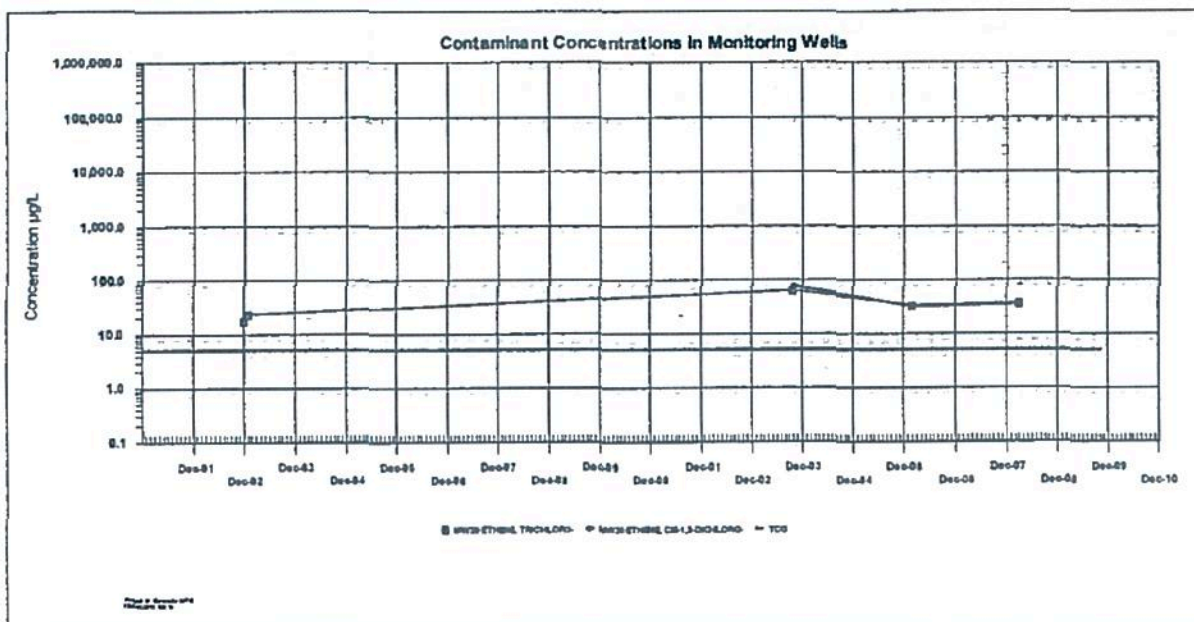
Contamination appears to have migrated off of the Grenada property beyond well MW20. Contaminant concentrations in well MW20 are shown in the report tables, but not on Figures 8 through 10 of the report. TCE concentrations in MW20 exceed the MCL and are increasing. DCE and VC are detected, but typically do not exceed the MCL. Some analyses were not conducted on the earlier samples. These are marked as "NA" in Table 5. Others are marked with "U" qualified results and no detection limit, so there is nothing to plot. The most recent TCE concentration is higher than the results in this well from early 1992, indicating the plume is expanding at a rate which exceeds the rate of natural attenuation.

Arsenic, lead and total chromium concentrations in MW20 have exceeded the MCL in the past. Relatively little data regarding metals concentrations in this well is available (Table 7 p.6/15). Iron, manganese and sulfate results are not shown in Table 7. These results, along with pH, conductivity, dissolved oxygen, oxidation-reduction potential (ORP) and turbidity should be shown on the metals analysis table to provide the data needed for interpretation of these results. Some of the parameters in this last group are presented in Table 8, but the data do not appear to be utilized anywhere in the report to interpret the sample results and the distribution of contamination.

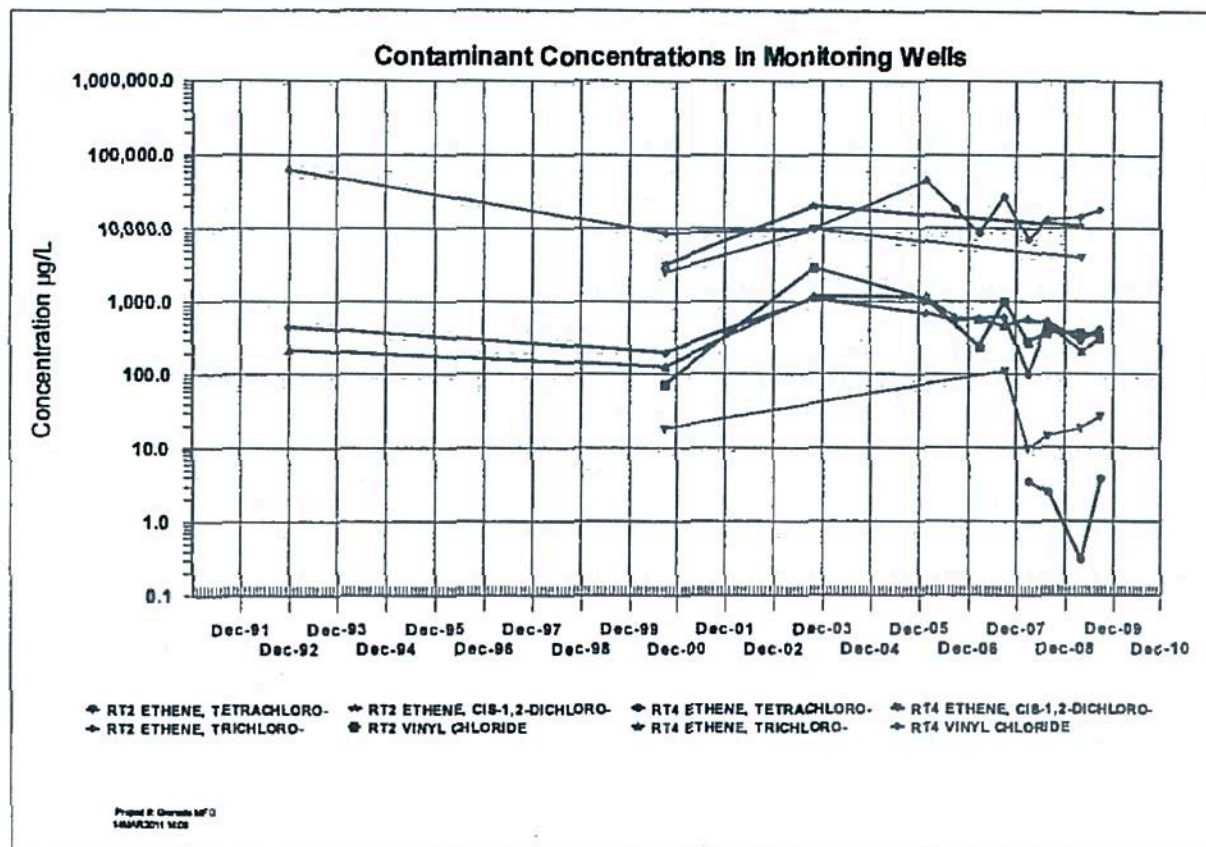
The following graph shows chlorinated VOC concentrations in wells RT-2 and RT-4. This graph was made from the data in Table 5, but the report does not contain any trend graphs. Please note the graph must be viewed in color to be useful because 4 contaminants from 2 different wells are plotted. The graph is busy, but purpose of this particular graph is to illustrate overall trends only. Two important observations to be made from this graph are:

- 1.) the concentrations in many wells exceed the relevant MCLs, and
- 2.) concentrations are not decreasing.

The last point can be verified with a ruler to draw a horizontal line across the graph. The oldest analysis result for many of these contaminants is less than the youngest result, showing that contaminant concentrations are increasing over the last 10-18 years despite any degradation by natural attenuation. The graph does not show a meaningful decrease in contaminant concentrations versus time.

The vinyl chloride concentration in RT-2 is a good example of increasing contaminant concentrations. In this case, the increase could be the result of degradation of other cVOCs, but the most recent vinyl chloride concentration is more than oldest VC concentration in this well. The most recent VC concentration in RT-2 is 150 times greater than the MCL. cis-DCE concentrations have increased in both wells and have exceeded the MCL since they were sampled first in 2000. The TCE concentration in RT-2 has increased since 2000 and, as shown on the graph, this increase probably is not due to degradation of PCE. Even the concentrations which are decreasing are decreasing at rate too slow to result in cleanup in a reasonable time. An average trend line through these data would be nearly flat and relatively little degradation is apparent over a time period probably equal to a few TCE half-lives.

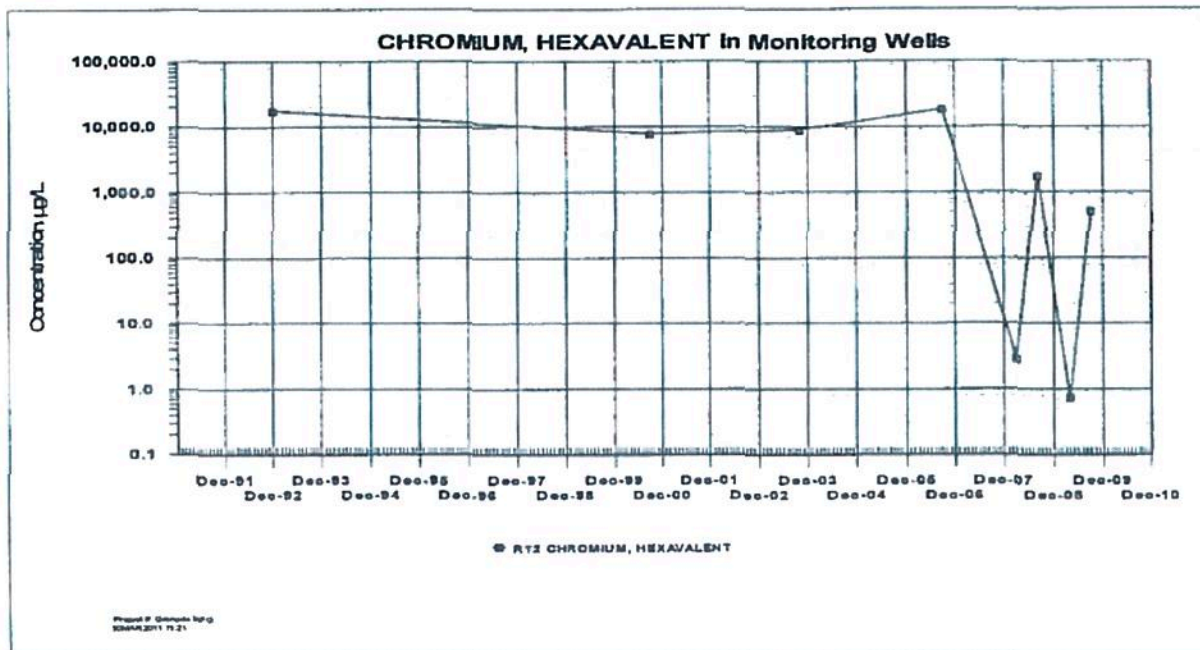
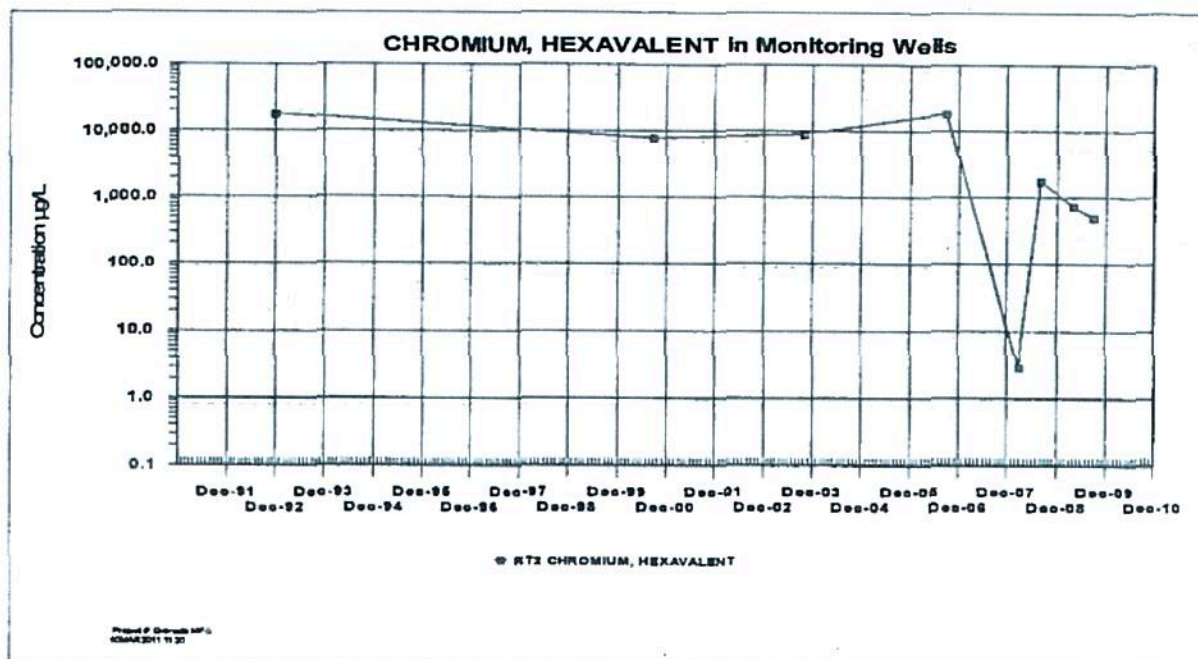
The trend graphs below show the difference between these two results.

You can see that the second downward pointing spike on the first graph disappears on the second graph when the value reported from Appendix B is plotted instead of the value in Table 7. I do not have the laboratory results for 2008 and cannot check the other downward spike shown on the graph. The 2008 data does not fit the hex-chrome data trend for this well.

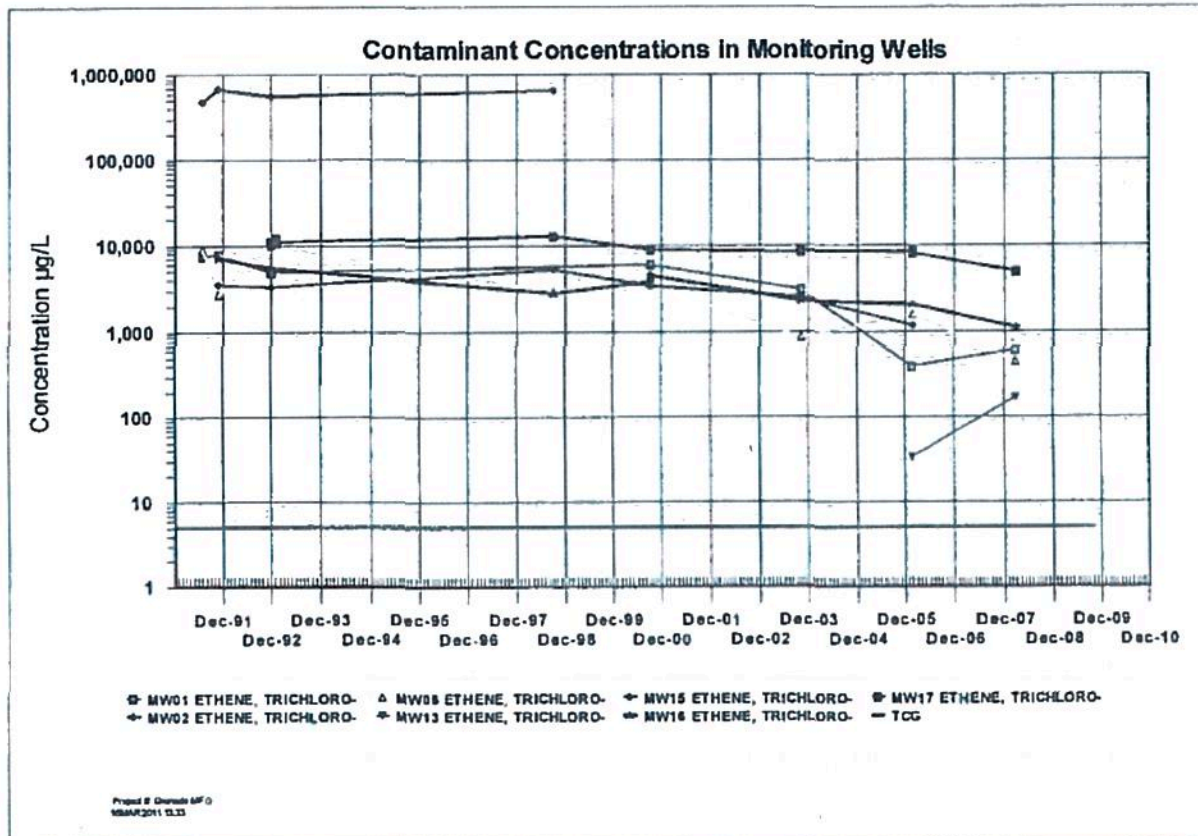
TCE concentrations in wells MW1, 2, 6, 13, 15, 16 and 17 from Table 5 are shown in the graph below:

All of these wells are hundreds of feet up gradient from the PRB wall (Figure 5). No figure in the report shows a TCE plume, but based on the TCE concentration in MW02 and the relatively stable TCE concentrations in MW17 over 15 years, the axis of this particular TCE plume is suspected to be in the upper zone near MW02. You can see that TCE concentrations in MW02 were very high when this well was sampled last in 1998. Well MW17 is located near this well, but MW02 is in the Upper zone while MW17 is in the Lower zone. TCE concentrations have decreased very little in MW17 since early 1993. Figure 5 shows there are no monitoring wells down gradient from MW02 and MW17 for at least 400 feet. The plume is migrating toward the PRB wall. The most contaminated portion of the facility has not been sampled since 1998.

The increasing TCE concentration in well MW13 is one piece of evidence that the margins of the plume are expanding northward (see the location of MW13 on Figure 5) and that the plume may flow around the north end of the PRB wall. There are not enough monitoring wells in the down gradient portion of this plume, particularly around the ends of the PRB wall.

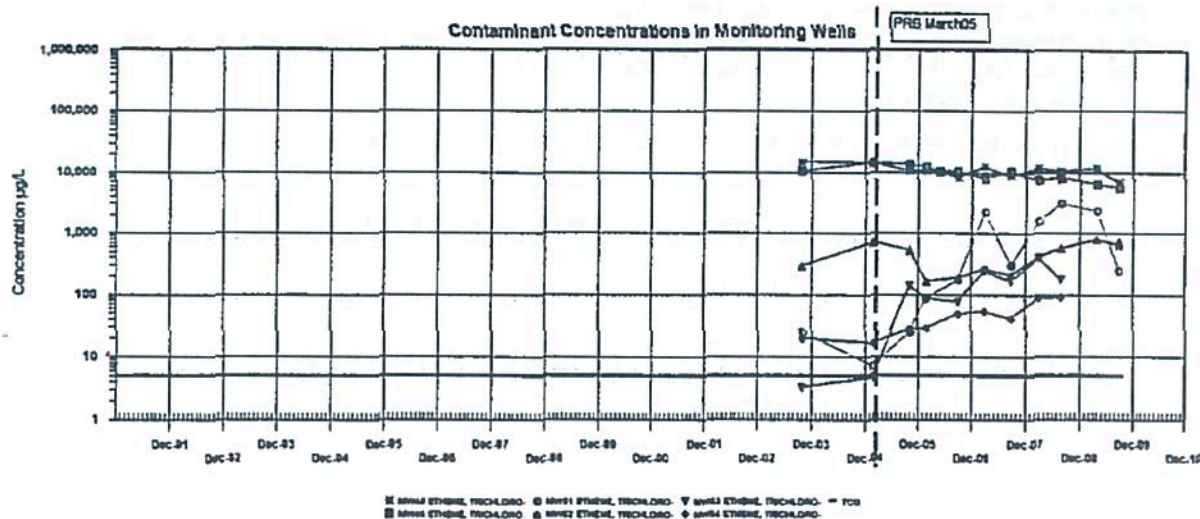
TCE concentrations in wells MW45, 46, 51, 52, 53 and 54 from Table 5 are shown in the graph below:

These wells are down gradient from the wells shown in the previous graph, but up gradient and relatively close to the PRB wall. Based on the relatively high and stable TCE concentrations, MW45 and 46 may be close to the axis of this TCE plume down gradient from MW02 and MW17. TCE concentrations in these wells are decreasing slightly, but are relatively stable, and are comparable with concentrations in up gradient well MW17 shown in the previous graph.

TCE concentrations in the deeper MW52 increased after 2006 and by 2009 became similar to concentrations observed when the wall was installed. TCE concentrations in the shallow wells MW51 and MW53 and deeper well MW54 all have increased since the PRB wall was installed. The increasing TCE concentration in these wells may be evidence that the margins of the TCE plume are expanding southward (see the well locations on Figure 5) and that the plume may flow around the south end of the PRB wall.

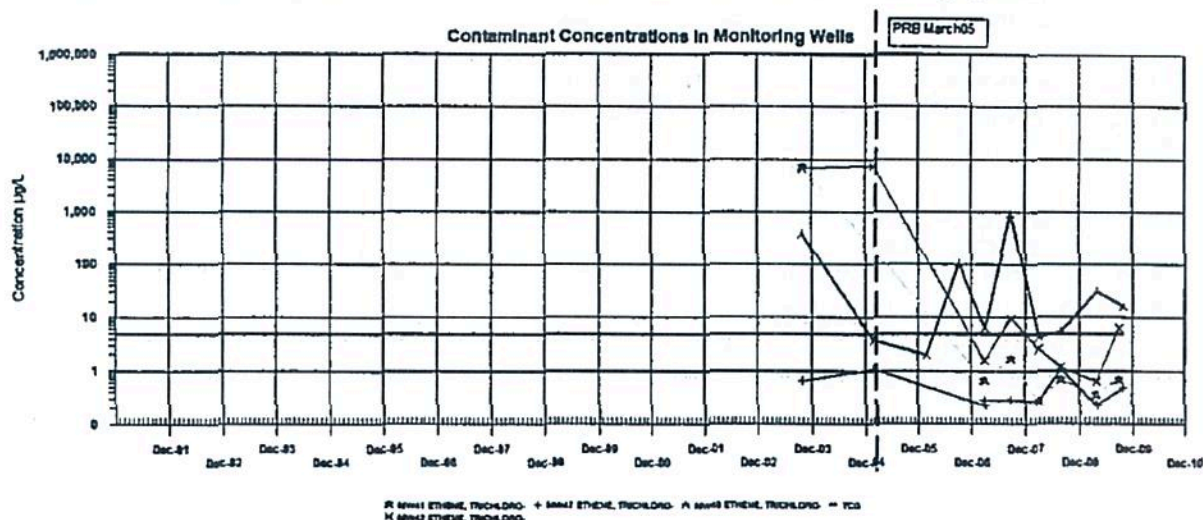
TCE concentrations in wells MW41, 42, 47 and 48 from Table 5 are shown in the graph below:

These wells are located down gradient from the PRB wall and away from the ends of the wall (see the well locations on Figure 5). TCE concentrations trends from these wells suggest the PRB wall lowered

TCE concentrations in these wells, though the concentration trend in deep well MW48 is erratic for reasons which are unclear at this time. The shallow well at this location, MW47, has never shown an exceedance for TCE. The erratic response in MW48 may be an indication that TCE contamination moves under the wall near MW48.

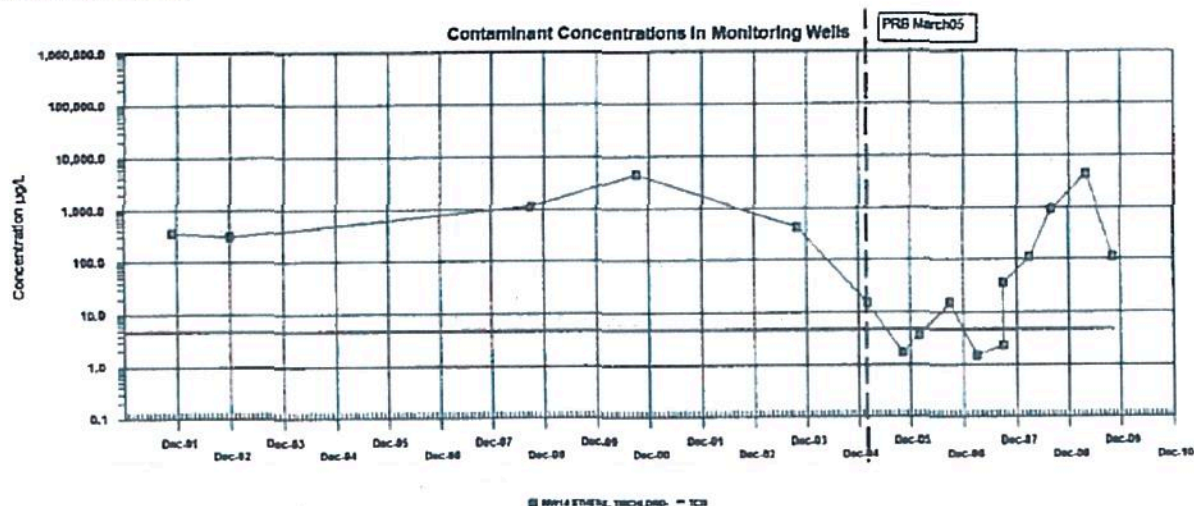
Unfortunately, on the down gradient side of the wall in MW14, the situation is even less clear as shown in the graph below.

The PRB wall may not have had any influence on TCE concentrations in well MW14. TCE concentrations were decreasing before the wall was installed. Three years after the wall was installed, TCE concentrations in this well increased to levels previously observed in 2000. The cause of these concentration variations is not addressed in the 2009 Monitoring Report. What is clear from Figure 5 is that MW14 is much closer to the surface water stream than it is to the wall. The TCE plume from MW14 discharges to the stream in this area. Without well screen depth information, without estimates of the vertical hydraulic gradient near MW14 and the stream and without information regarding the depth of the PRB wall, further interpretation of these data is not possible.

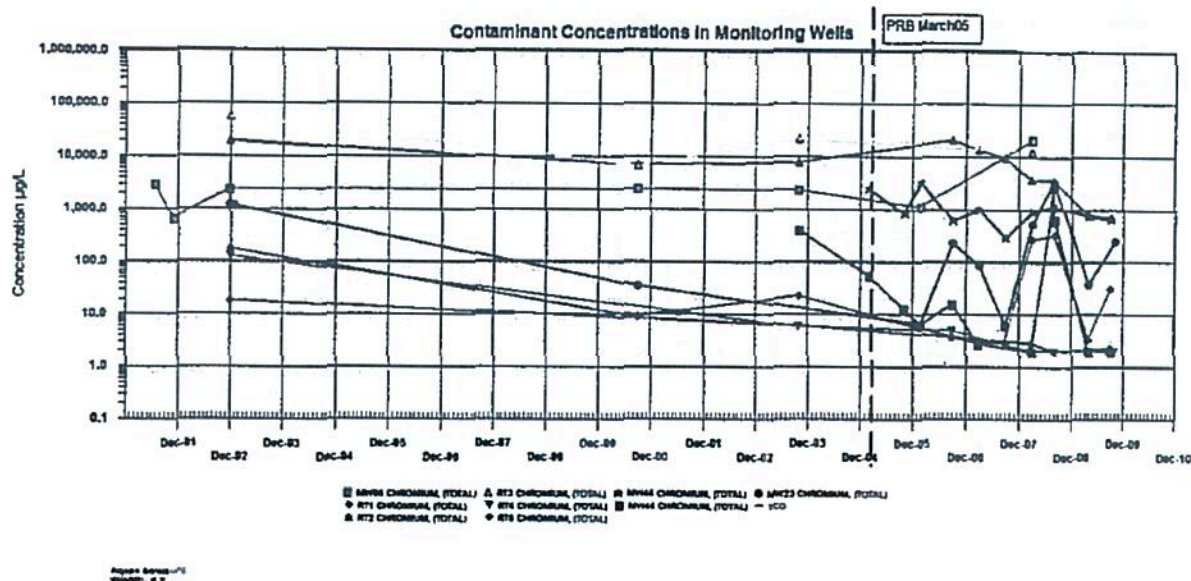
The MCL for total chromium is 100µg/L. Total chromium trends in selected wells are shown in the graph below and described in the following paragraphs.

Total chromium concentrations in MW06 have exceeded 1,000µg/L in 7 of 8 samples since 1991 and concentrations are increasing (Table 7 p.2/15).

Total chromium concentrations in the background well MW23 appear to be increasing, but the trend is very erratic for reasons not explained in the 2009 Monitoring Report. MW23 is the most up gradient well with MCL exceedances for total chromium, but with the erratic trend, the chromium source may be farther up gradient.

Total chromium concentrations in well RT3 have exceeded 10,000µg/L in all but one sample since the earliest reported samples in 1992.

Total chromium concentrations in well RT2 have exceeded 10,000µg/L in most samples before 2008, but recently have declined to 750µg/L.

Total chromium concentrations in shallow well MW45 always exceed the MCL. Total chromium concentrations in well deeper well MW46 sometimes exceed the MCL, but the trend is erratic. The erratic trend in MW46 may be an indication that contamination sometimes passes under the wall at this location, but no information regarding the hydraulic gradients in this well pair is provided. Both of these wells screens are located relatively close to the PRB wall and are far down gradient from the RT wells.

Total chromium concentrations in well RT5 sometimes exceed the MCL, but the occasional exceedances are greatly different from the other results from this well. Turbidity in the sample might cause this response, but turbidity is not reported on Table 7.

Total chromium concentration in well RT1 has never exceeded the MCL and total chromium concentrations in well RT4 exceed the MCL only in January 1993. I first thought the old lagoon was the source of the chromium, but the typically low chromium levels in wells RT1, RT4 and RT5 suggest this is not true. MW23, RT2 and RT3 all are on the south side of the lagoon. The source of the total chromium plume is not clear from the data presented and the location of the plume is not shown on any map in this report. The extent of total chromium contamination in groundwater appears to extend from the PRB up gradient at least as far as MW23.

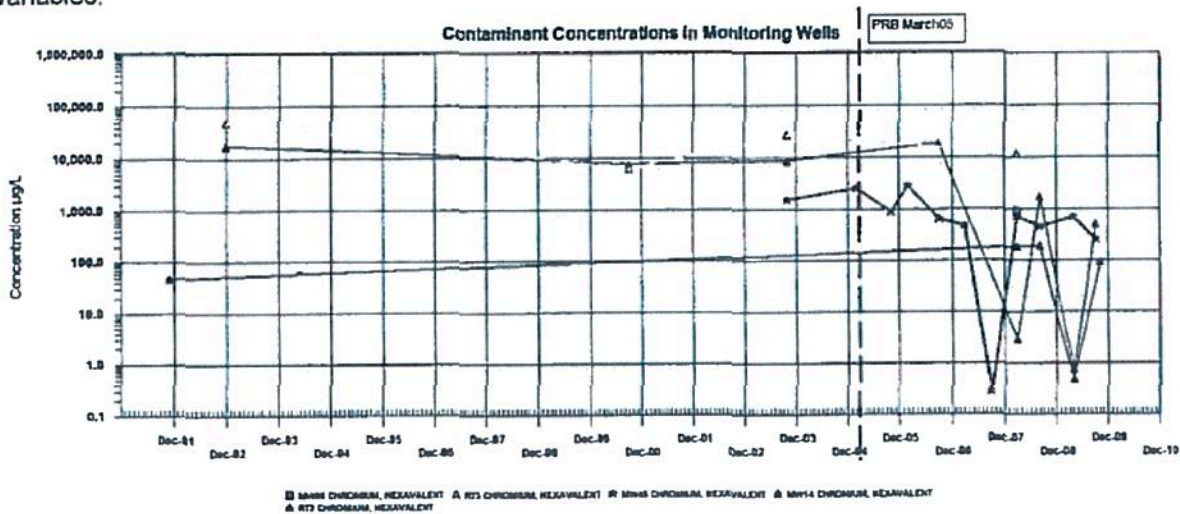
HEXAVALENT CHROMIUM: There is no MCL for hexavalent chromium. Elevated concentrations of hexavalent chromium, defined for this memo as greater than 10µg/L simply to identify wells with higher hexavalent chrome levels, are observed from most samples in wells MW06, MW14, RT2, RT3, MW45 and once in MW46 (not plotted below). MW14 is down gradient from the PRB where groundwater will not

be treated. The cause of the "W" pattern in the trend graph below is unclear. Possible causes include unit conversion errors, turbidity in the samples, laboratory problems and other sampling procedure variables.
